BMP Pilot Studies

Quarterly Status Report No. 5

BMP Pilot Projects in District 7 and District 11

CTSW-RT-99-085 June 15, 1999

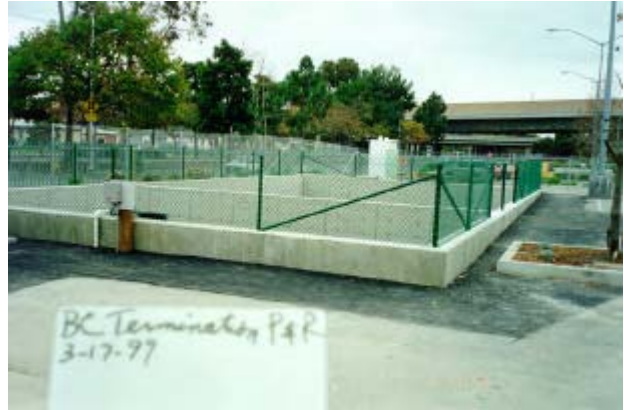
Termination Park and Ride Media Filter (Site ID 74204)

Service agreement between Brown and Caldwell and Greater LA County Vector Control District was executed on May 13, 1999. GLACVCD visited the site the week of 5/17; a large amount of mosquito pupae were observed and treated with Golden BearTM oil. Installation of screens to minimize vector activity is scheduled to be complete by mid-June. Brown and Caldwell is looking at the possibility of installing a ladder at the media filter chambers for vector sampling (and maintenance).

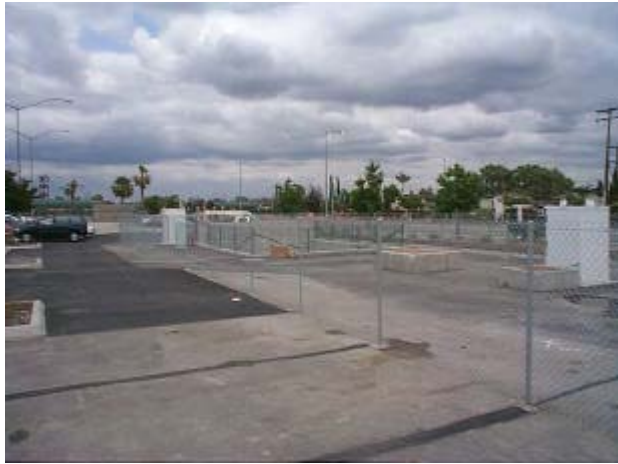
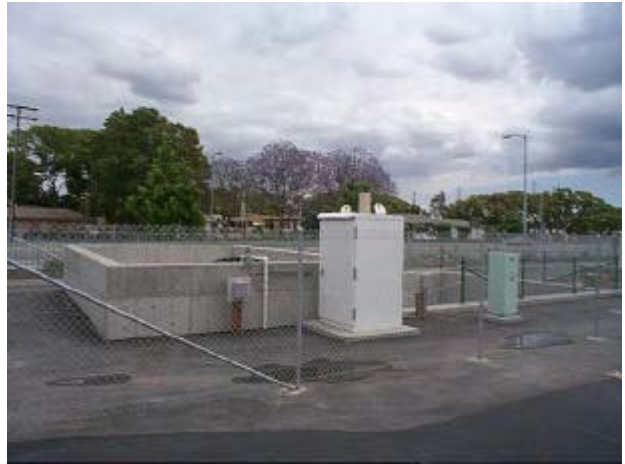
Lakewood Park and Ride Multi Chamber Treatment Train (Site ID 74208)

Service agreement between Brown and Caldwell and Greater LA County Vector Control District was executed on May 13, 1999. During the week of 5/17, mosquito larvae were found in the sump well and treated with VectolexTM. During the week of 5/31, dense populations of mosquito pupae were treated with Golden BearTM oil. Brown and Caldwell is looking at the possibility of installing a ladder at the MCTT chambers for vector sampling (and maintenance). Installation of screen to minimize vector activity is scheduled to be complete by mid-June.

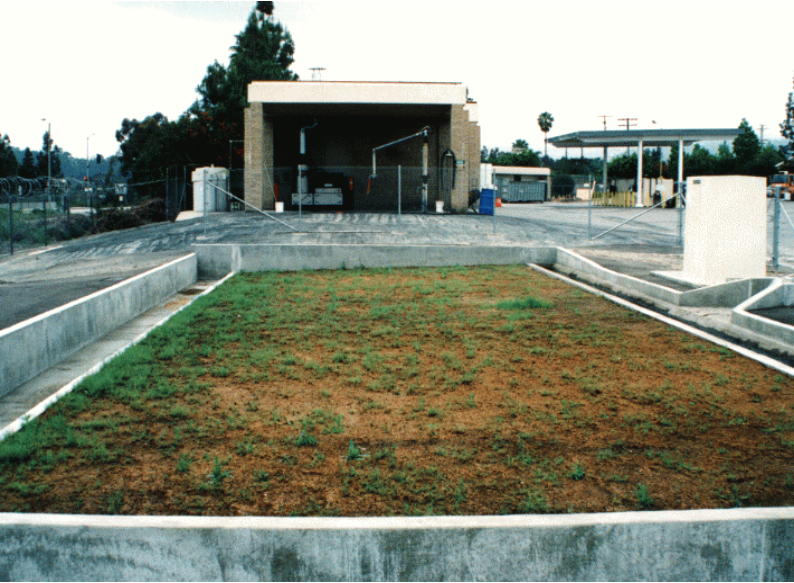
Altadena Maintenance Station Bio-Strip and Infiltration Trench (Site ID 73211 a, b)

Construction was completed on March 12, 1999. No additional work was performed since the last quarterly status report. Site was not deemed operational due to inadequate coverage of salt grass at the biofiltration strip.

The site is not operational – saltgrass coverage requirement not yet achieved. Saltgrass coverage is about 40%; irrigation will continue. See Appendix H for additional information relative to the condition of the sod.

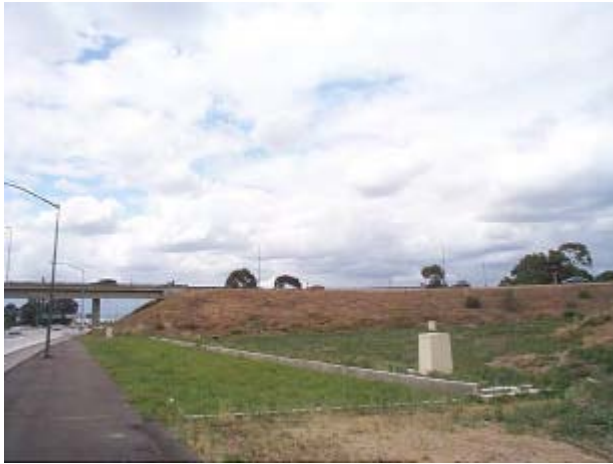
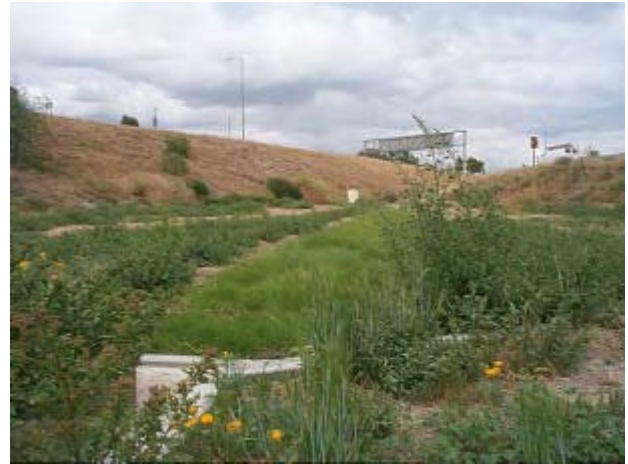
I-605/SR-91 Interchange Bio Strip & Swale (Site ID 73222 a, b) MW/Law

Construction was completed on March 12, 1999. No additional work was performed since the last quarterly status report. Site was not deemed operational due to inadequate coverage of salt grass at the biofiltration strip and swale.

Service agreement between Montgomery Watson and Greater LA County Vector Control District was executed the week of May 31, 1999. During the week of 5/31, mosquito larvae at the site were treated with VectolexTM (see Page 42 for description). Vector activity was noted on 3/11; the VCD was notified.

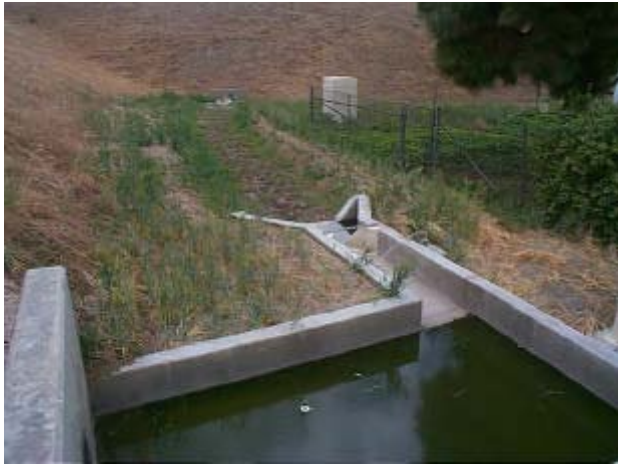
Cerritos Maintenance Station Bio Swale (Site ID 73223)

Construction was completed on March 12, 1999. No additional work was performed since the last quarterly status report. Site was not deemed operational due to inadequate coverage of salt grass at the biofiltration swale.

Service agreement between Montgomery Watson and Greater LA Vector Control District was executed the week of May 31, 1999. Monitoring by GLACVCD at the beginning of June showed that the energy dissipater contained standing water. UCR personnel have previously noted vector activities at this site (Feb and Mar); the VCD was notified.

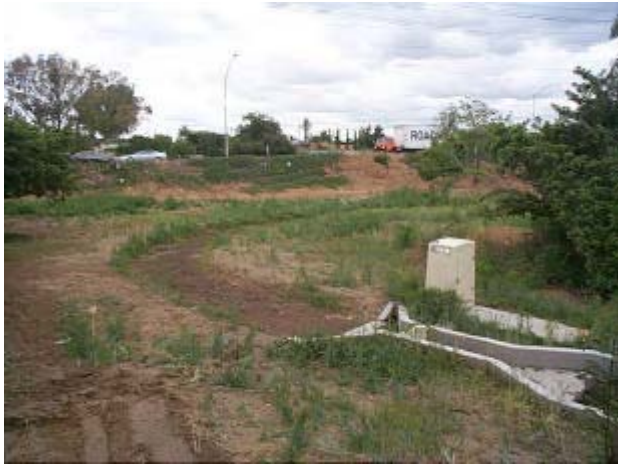
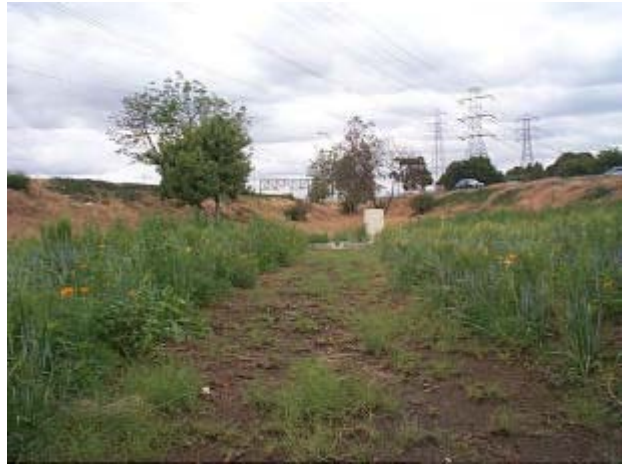
I-5/I-605 Bio Swale (Site ID 73224)

Construction was completed on March 12, 1999. No additional work was performed since the last quarterly status report. Site was not deemed operational due to inadequate coverage of salt grass at the biofiltration swale.

Service agreement between Montgomery Watson and Greater LA Vector Control District was executed the week of May 31, 1999. During the week of 5/31, dense populations of mosquito pupae were treated with Golden BearTM oil. UCR personnel previously noted vector activity at this site (April 20). Egg rafts were collected on 4/20.

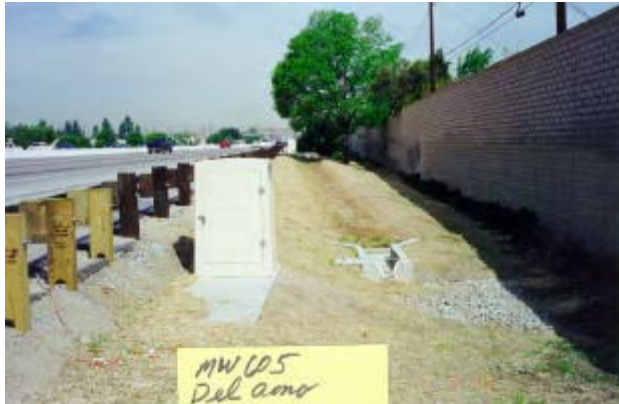
I-605/Del Amo Bio Swale (Site ID 73225)

Construction was completed on March 12, 1999. No additional work was performed since the last quarterly status report. Site was not deemed operational due to inadequate coverage of salt grass at the biofiltration swale.

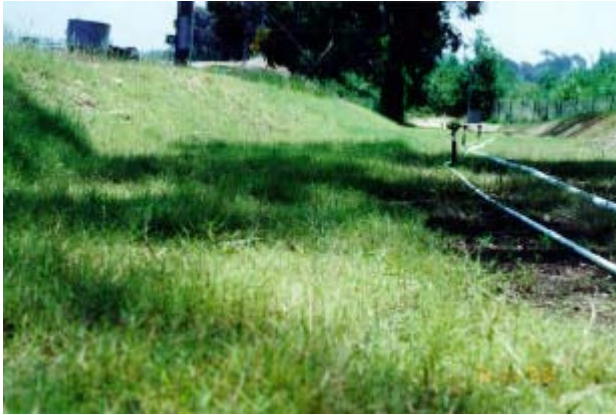
Melrose Ave/SR-78 Bio Swale (Site ID 112205)

Construction was completed on February 26, 1999. No additional work was performed since the last quarterly status report. Site was not deemed operational due to inadequate coverage of salt grass at the biofiltration swale.

KLI and Martha Blane visited the site on May 14 to assess the condition of vegetation at the site. It was decided that all non-grasses will be weeded and organic debris (i.e., leaves and acorns) will be removed in mid-June.

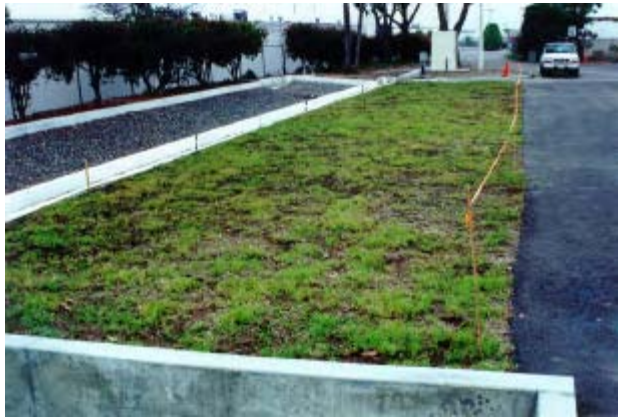
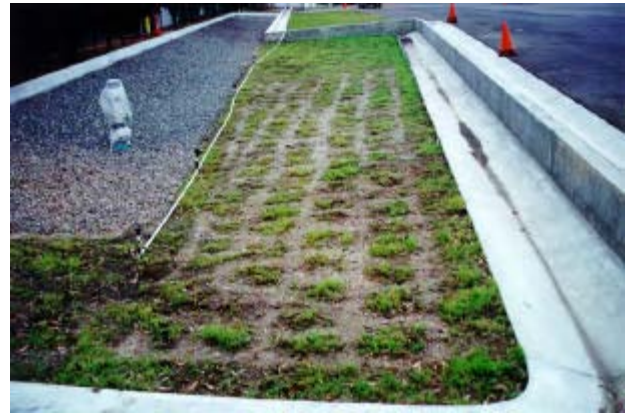
Carlsbad Maintenance Station Bio Strip Infiltration Trench (Site ID 112207)

Construction was completed on February 26, 1999. No additional work was performed since the last quarterly status report. Site was not deemed operational due to inadequate coverage of salt grass at the biofiltration strip.

KLI and Martha Blane visited the site on May 14 to assess the condition of vegetation at the BMP site. All non-grasses will be weeded and organic debris (i.e., leaves and acorns) will be removed in mid-June.
